Manhole Inspection Summary

Manhole # S05EE2016MH

Location Address: **2706 HANSON AVE**

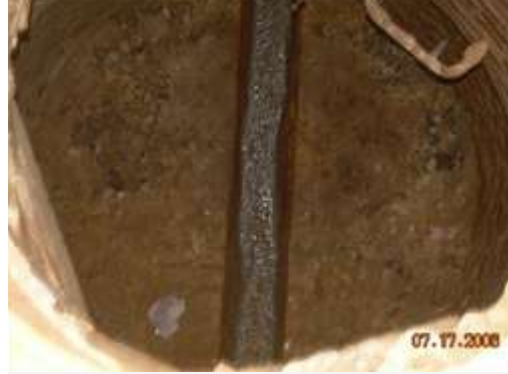
Top View

Condition: ☐ Sound ☐ Cracked ☐ Root Intrusion ☒ **Loose Brick** ☐ Deteriorated

Infiltration: ☐ None ☒ **Joint** ☐ Cracks ☒ **Mortar** ☐ Roots ☐ Wall

Surcharge ☒ **Evidence Of Surcharge** Depth: **2** (ft.) ☐ Active Surcharge Present

Adjustment loose brick. Adjustment infiltration. Evidence of surcharge - Bench debris.

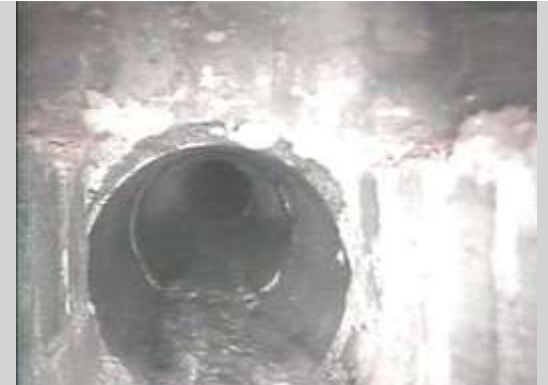
8 in. Circular Gravity Sewer Pipe Out @ 12 O'Clock

Infiltration: **Evidence** Pipe Seal Cond: **Unknown**

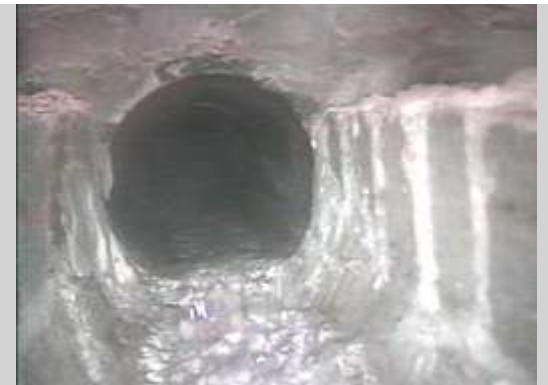
8 in. Circular Gravity Sewer Pipe In @ 6 O'Clock

Infiltration: **Evidence** Pipe Seal Cond: **Unknown**
